2018 WATER QUALITY MONITORING REPORT FOR  
**SAGAMORE CREEK**

FOR THE CITY OF PORTSMOUTH, NH

[June 2019]

**FB ENVIRONMENTAL ASSOCIATES**

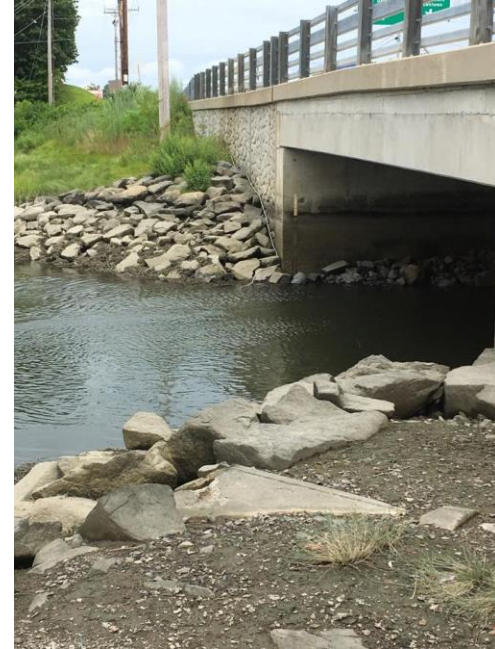
**TOP:** 04-SAG on 8/1/18 during logger deployment. The anchor line can be seen connecting the loggers underwater to the telephone pole. Photo: FBE.

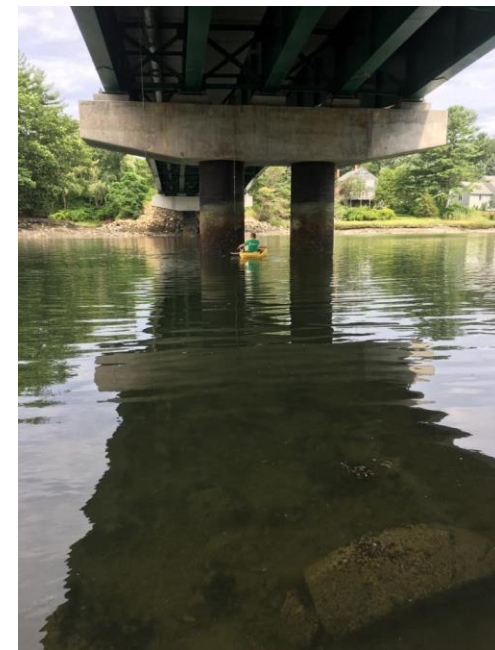
**BOTTOM:** FBE Scientist, Amanda Gavin, deploying a data sonde at 02-SAG via kayak. Photo: FBE.

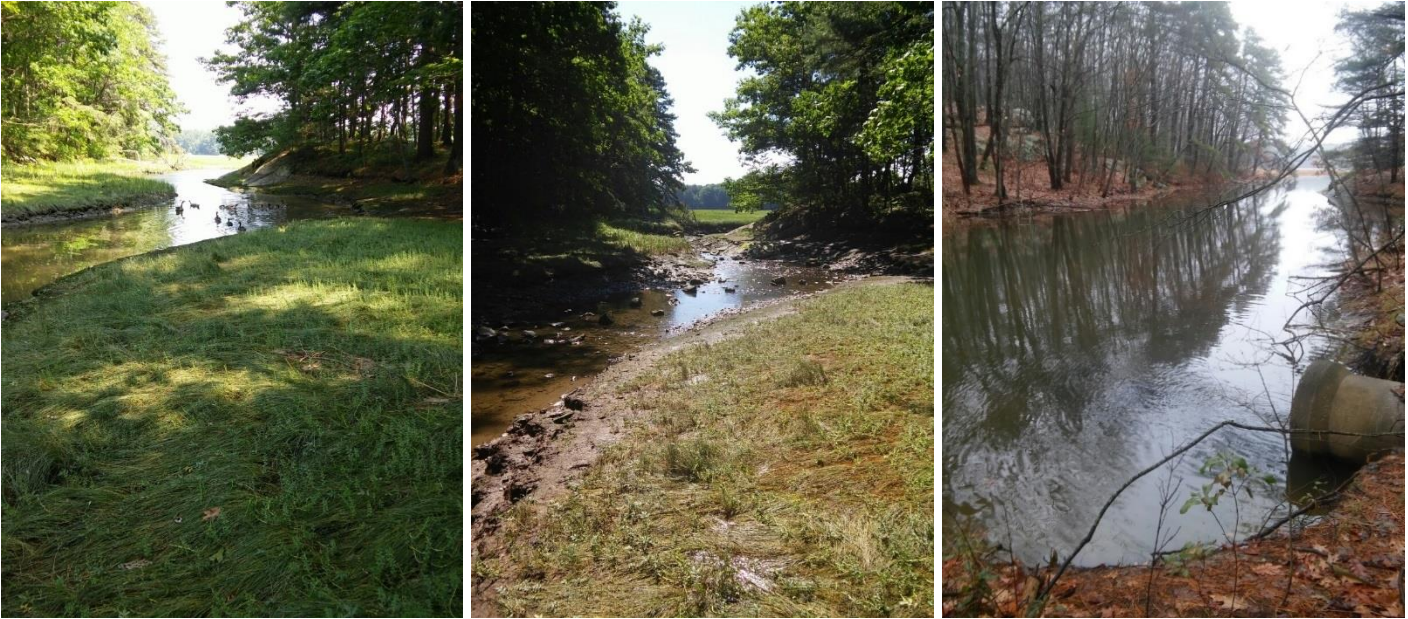
**SGC-03** was often observed being used by a flock of Canada geese (**Left**: 7/2/18). Canada geese are a notorious source of fecal contamination to waterways. SGC-03 is also influenced by tidal cycles and can be seen at low tide on 7/18/18 (**Center**) and high tide on 12/3/18 (**Right**). During the 12/3/18 high tide following a rain event, water can be seen rising up over the bank and flooding the grassy area where the Canada geese once grazed. Photos: FBE.

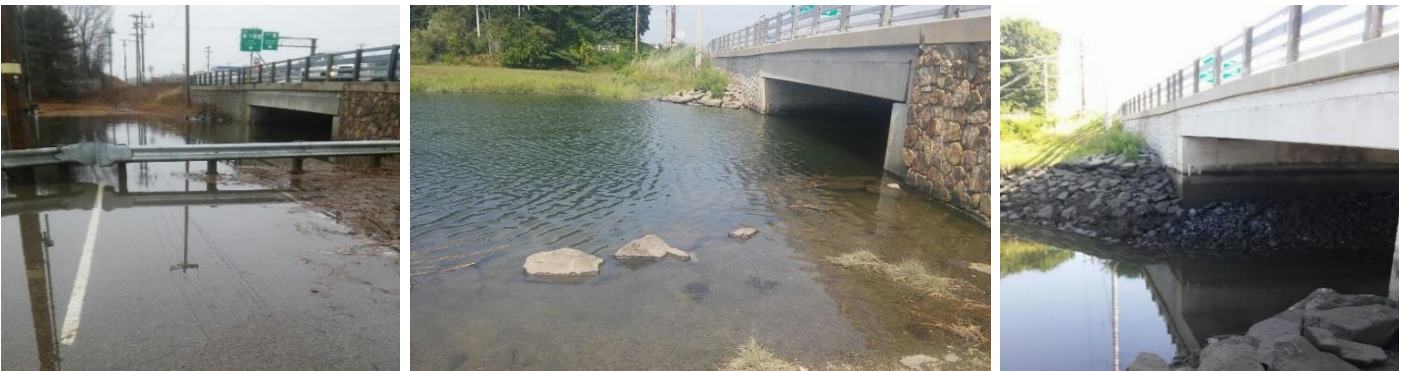
**04-SAG** is influenced by tidal cycles and regularly overflows into an adjacent parking lot during spring or king tides and storm events, possibly carrying pollutants from paved areas into the Creek. **Left**: following a storm event on 12/3/18. **Center**: high tide on 8/28/18. **Right**: low tide on 8/29/18. Photos: FBE.

- **04-SAG** exceeded the state geomean criterion of 35 mpn/100mL for Enterococci (driven by high single-samples near or >2,419 mpn/100mL following wet weather on 7/18/18 and a maximum of 19,863 mpn/100mL following a storm event on 9/26/18) and had the greatest range in chlorophyll-a concentrations (high range associated with warm temperatures during low tide, baseflow conditions) of the sampled sites. There are multiple potential sources contributing pollutants to 04-SAG, including sources to the six previously-described sites upstream of 04-SAG, with SGC-04 likely the most significant contributor. An inverted syphon to 04-SAG also connects a low-lying sewer line through the Urban Forestry Center; the sewer line needed regular clean-outs after heavy rains up until about six years ago. A small, uncapped and unlined landfill was used in the 1950's and 1960's in the area around Mirona Road and the former Iafolla property (currently owned by the Portsmouth DPW and PIKE Industries); soil tests and groundwater monitoring have since revealed soil contamination from sludge and other refuse disposal that may also be contaminating the marsh area draining to 04-SAG.

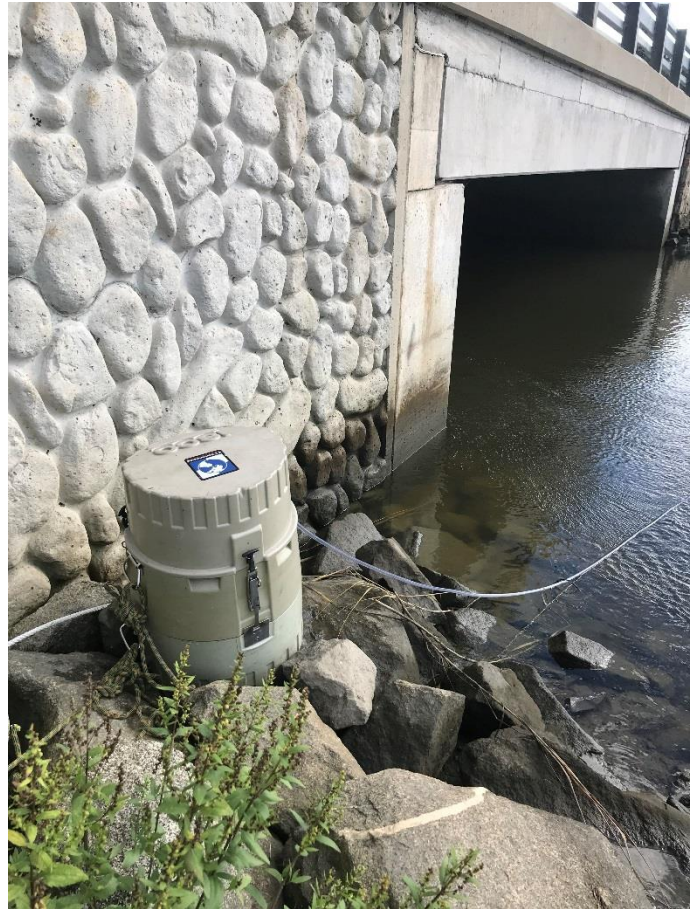
**Automated sampler deployed at 04-SAG from 9/24-28/18.**

Collecting samples over a lunar day (just over 24 hours) that captures two or more full tidal cycles can highlight changes in water quality because of both tide and daily fluctuations that would otherwise be missed during regular sampling. Following protocols set forth in the Great Bay Estuary Water Quality Monitoring Program QAPP 2018 and the National Estuarine Research Reserves System Wide Monitoring Program (SWMP), an automated sampler (ISCO6700) was deployed at 04-SAG and was set to collect 48 one-liter samples every 2 hours, 4 minutes over the course of eight full tidal cycles from 9/24-28/18 before, during, and after two small rain events (0.90" on 9/25/18 and 0.70" on 9/26/18). Samples were analyzed for the same parameters and by the same laboratories as for the synoptic sampling for tidal sites. A subset of 30 out of the 48 samples were analyzed for Enterococci due to conflicts with maximum hold times (6 hours) and laboratory operation hours.
