SWAG Meeting

September 10, 2024 | 6:00-8:00pm

Bellamy Reservoir Tour

Hybrid Meeting: Madbury Water Treatment Facility and via Zoom

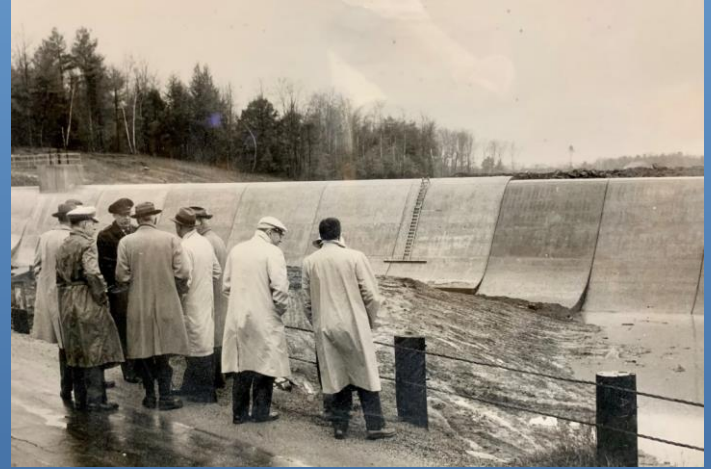
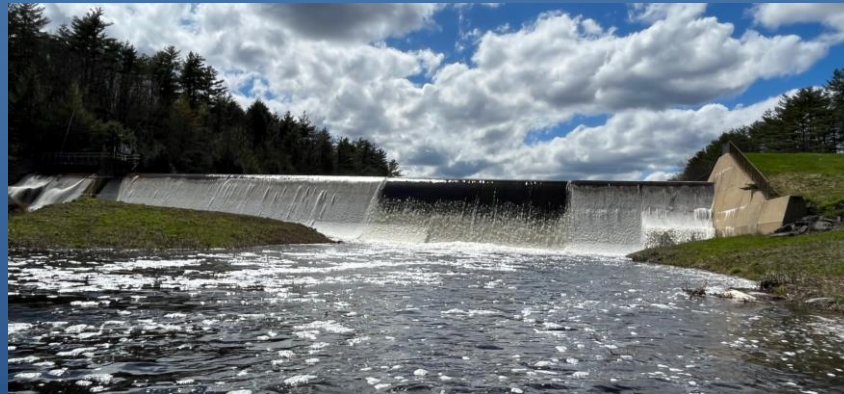
Bellamy Reservoir

- Constructed 1957-1960
by the US Army Corps of Engineers
- Reservoir Area: ~400 acres
- Maximum Depth: 28 feet
- Full Volume: 730 MG
- Average Flushing Rate: 9x/year
- Watershed Area: 22 sq. miles

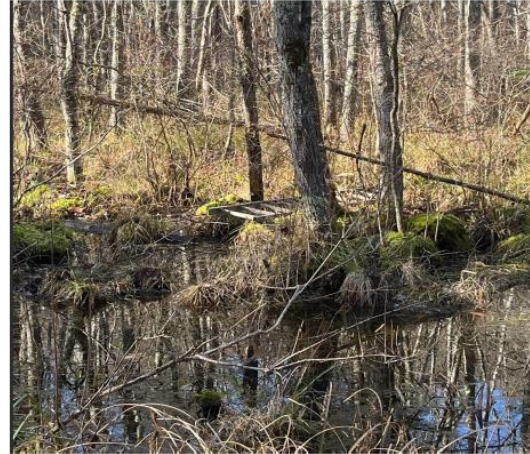
Photo Point #5

Figure 5. Ladder sitting in swampy area that connects part of the Bellamy River to the reservoir.
Note: Located across the river in an inaccessible location on the property due to water level.

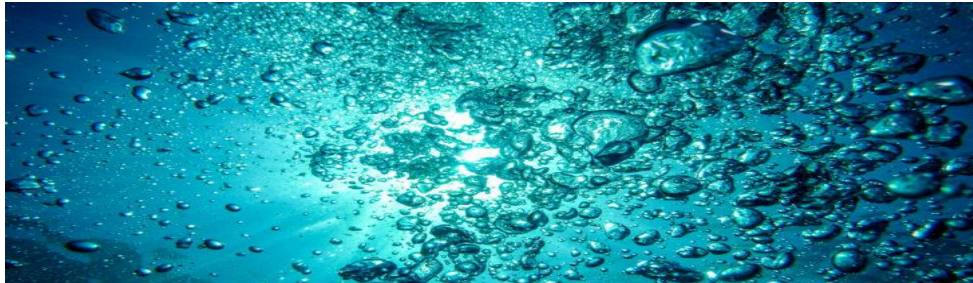
Benefit of Dissolved Air Flootation (DAF) System

- Most toxin-forming cyanobacteria tend to float to the surface; therefore, a DAF system is more effective for removal of these blooms than conventional systems
- Coagulation, and flocculation also play a role in cyanobacteria removal: binding cyanobacteria cells to the floc
- Cyanobacteria is skimmed off the surface, allowing for the removal of cyanobacteria cells without causing cell damage

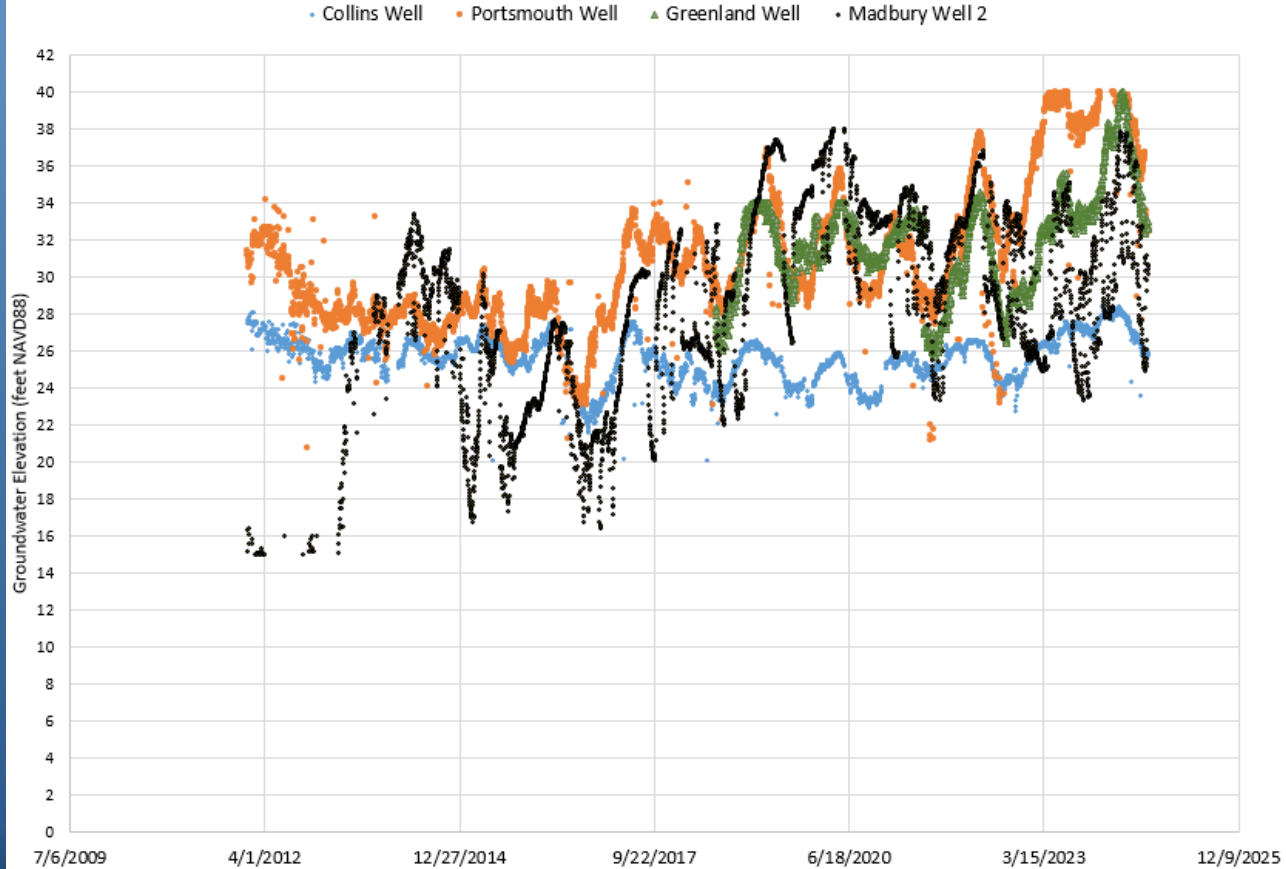
Supply Well Water Elevations

Groundwater Levels

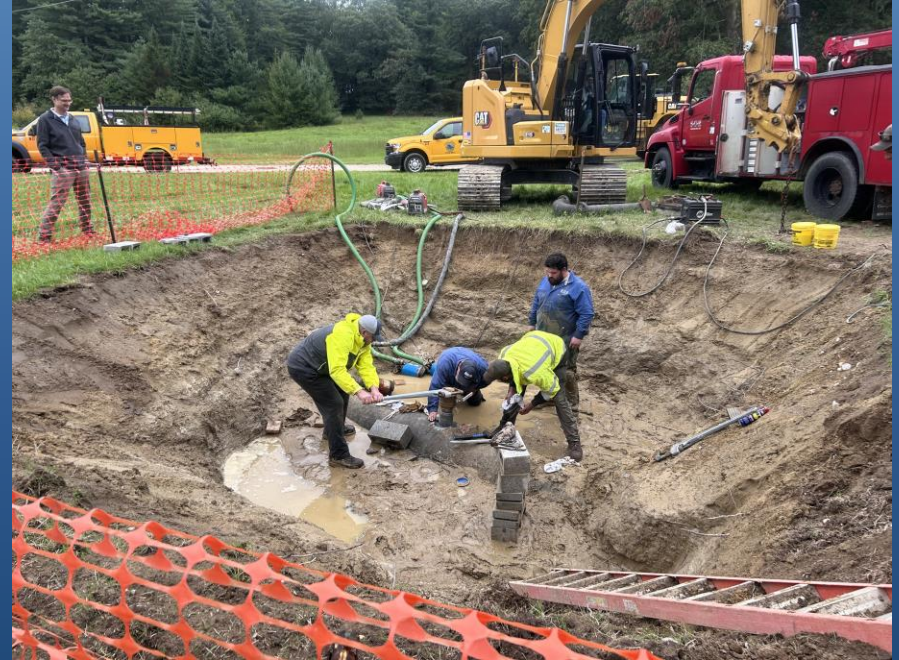
Transmission Main Air Relief Valves and Easement Clearing

- Air Relief Valves are failing. One in Madbury was replaced in August 2024. Need to assess replacement of the other 26 valves
- Easement maintenance/clearing along the main from reservoir to Newington

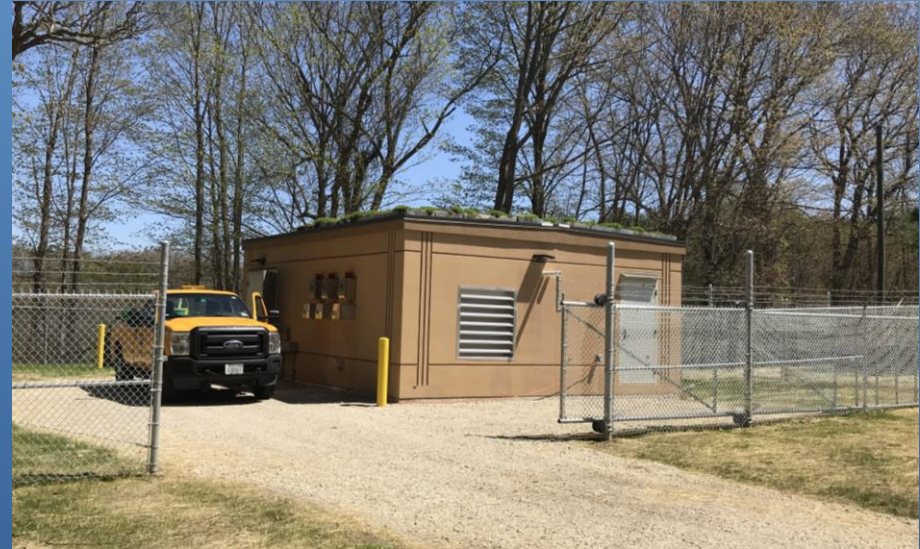
PFAS Treatment Design

- Greenland Well
 - Preliminary design near completion
 - Granular Activated Carbon
 - New building needed
 - Road and power upgrades required
 - Proceeding with final design
