Portsmouth Municipal Complex

Strategies for programmatic and physical plant improvements
to better serve the public

Portsmouth City Hall North Façade Replacement - Design Options
CITY COUNCIL RETREAT- 10/1/2016

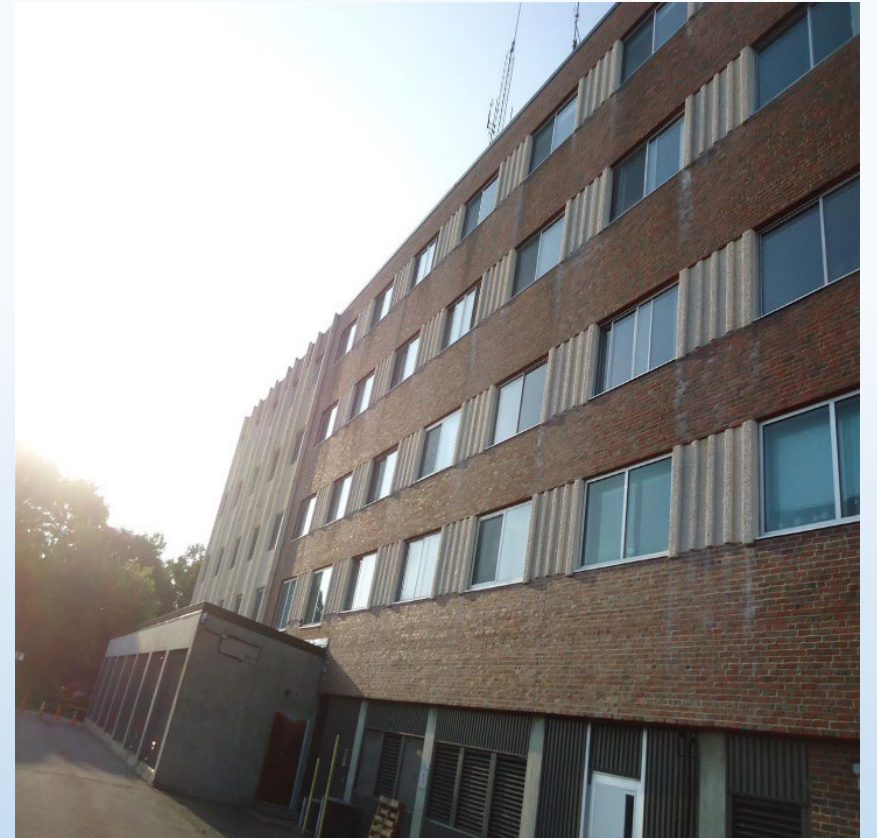
NORTH WALL FACADE

- Gale Associates inspected the failed masonry and windows and prescribed a temporary stabilization plan, implemented by the City immediately.
- The permanent repair is to be put in place in 2017, with an estimated cost of approximately \$3.2M.

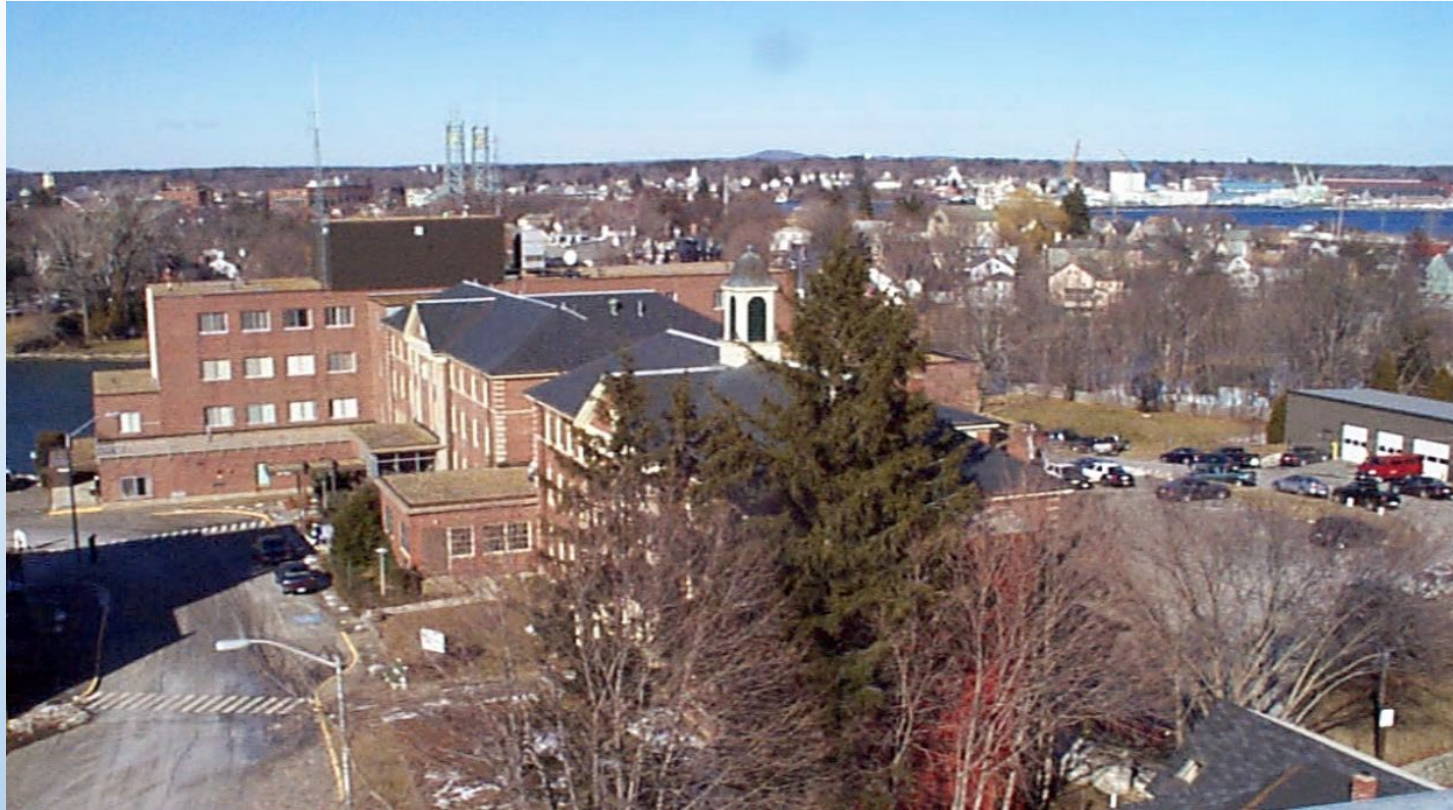
- Relocate the PD to a 4 acre site.
- Renovate Municipal Complex, without PD.
- Renovate PD at existing site to address 2035 projected needs.
- Renovate CH to address 2035 projected needs in the existing complex.
- Sell Municipal complex, relocate CH and PD.

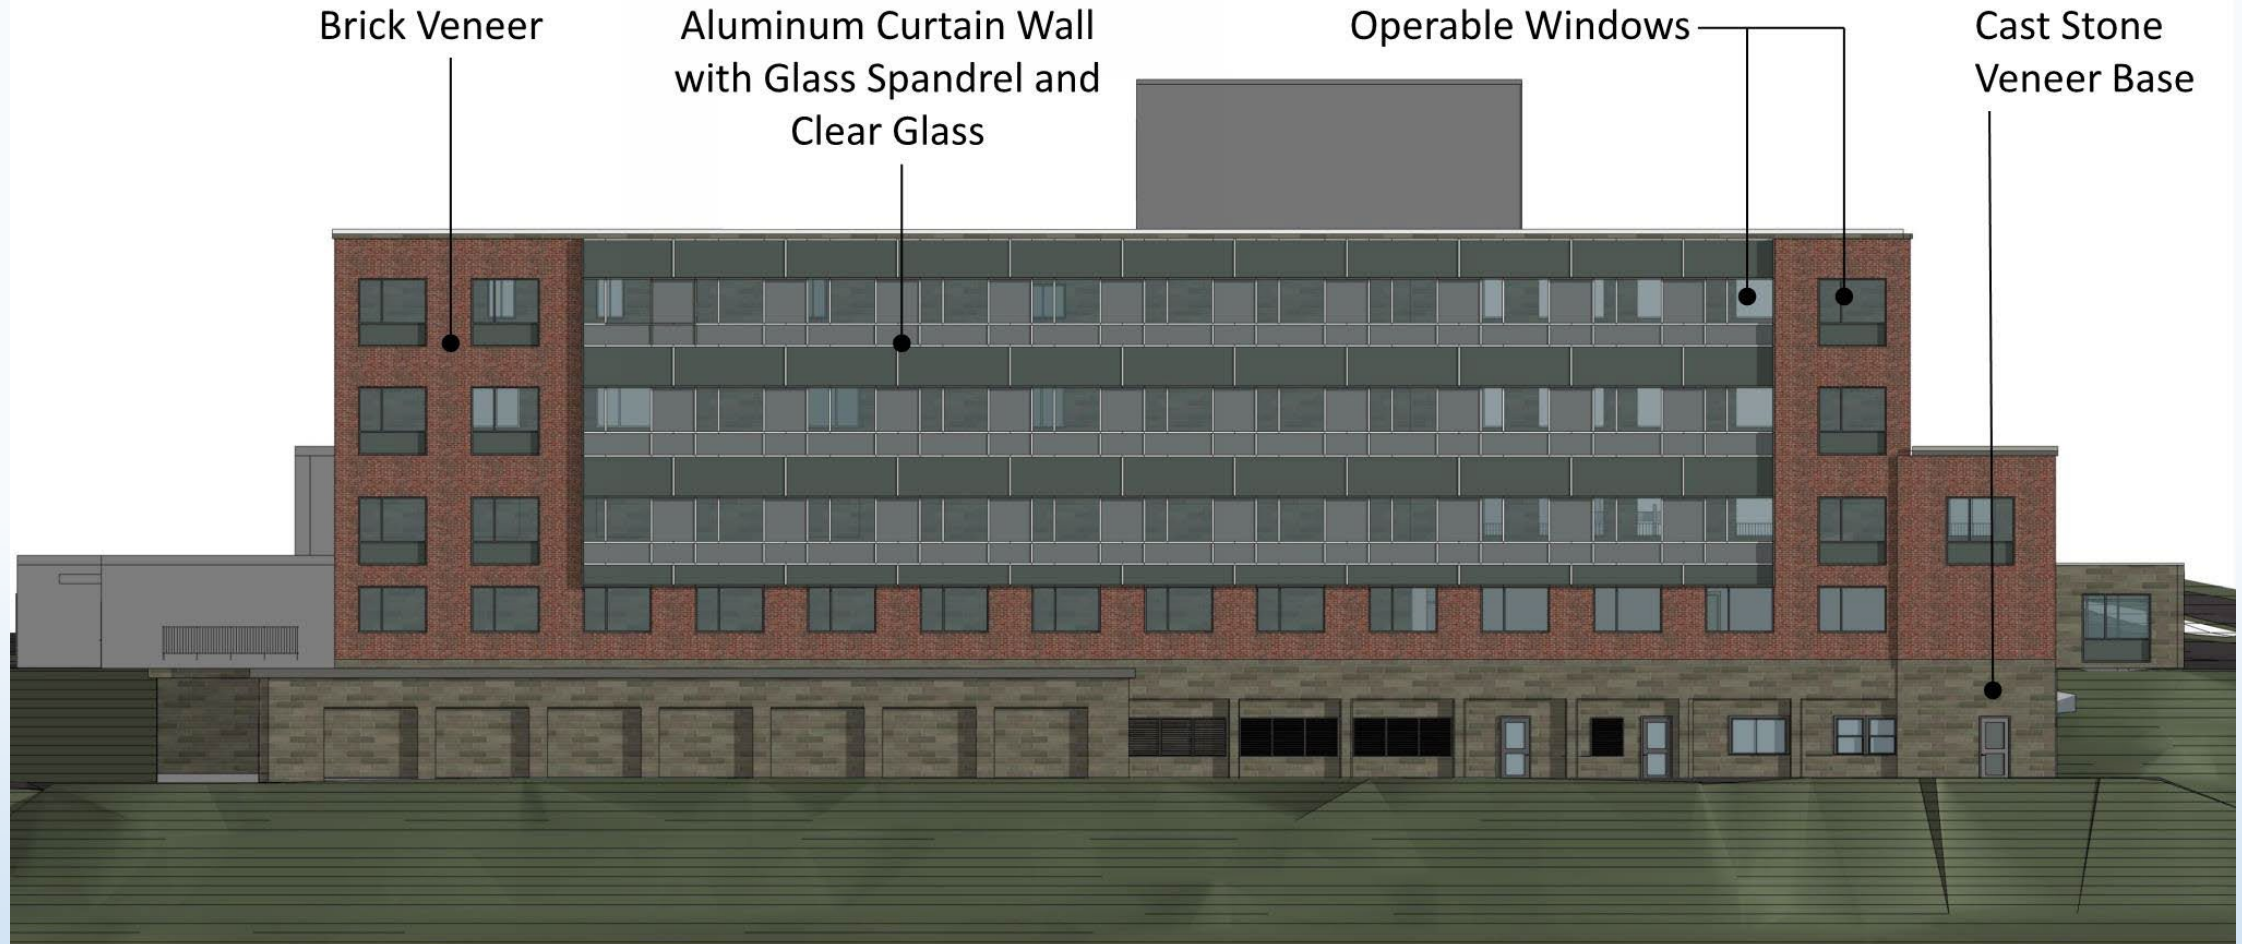
OPTION B – CURTAIN WALL & MASONRY (ALTERNATE COLOR PALETTE 3)

- Mix of vision glass and one or more colors of spandrel (non-vision) glass
- Areas of spandrel allow for adequate insulation behind curtain wall
- Cast Stone Veneer Base wraps corner facing Junkins Avenue
- Updated Police Station entrance matching cast stone base
