CITY OF PORTSMOUTH

Facility Condition Assessment

Municipal Complex

Asset 0001

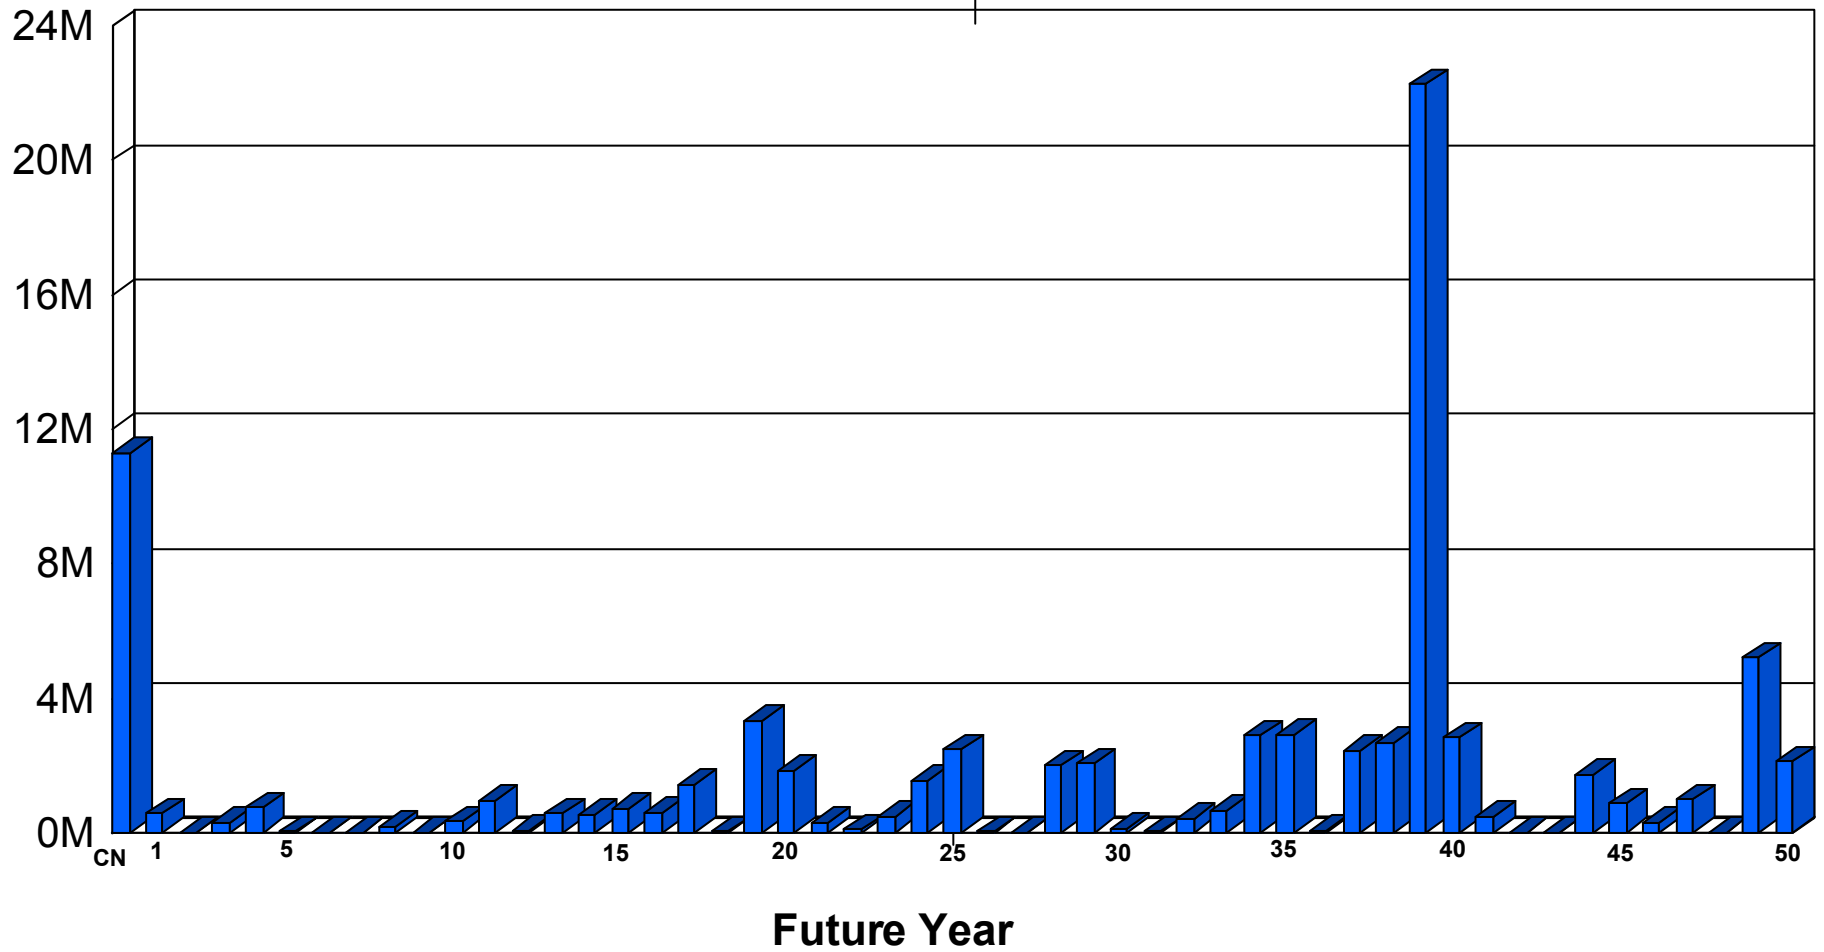
Recurring Component Expenditure Projections

0001 : MUNICIPAL COMPLEX

Average Annual Renewal Cost per SqFt \$5.91
